Technical Bulletin

Subject
**Possible Water Entry Areas
on Targa Vehicles**

Number
9601

Models Affected: *911 Targa, Model Year 1996*

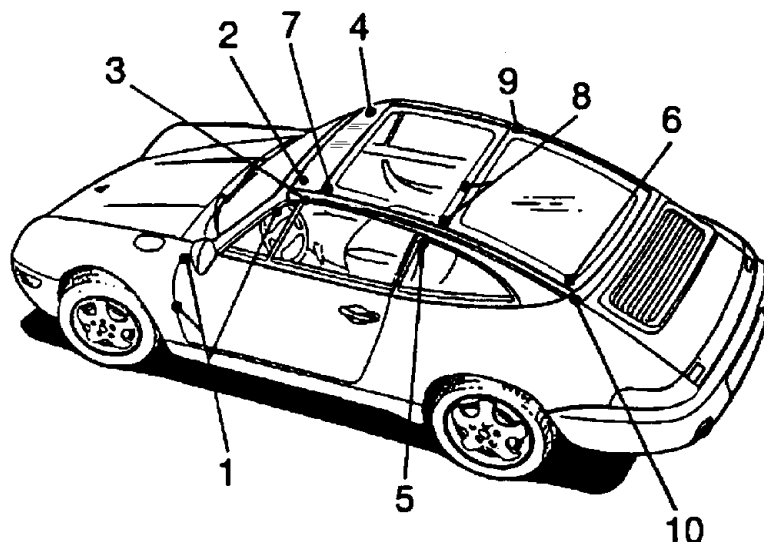
Possible water entry areas include:

- 1 - Water entry on the left and right door seal.
- 2 - Water entry above the left and right "A" pillar - windshield frame/ roof module.
- 3 - Water entry on the formed seal piece of the left and right top door seal / "A" pillar.
- 4 - Water entry on the air deflector.
- 5 - Water entry on the left and right "B" pillar.
- 6 - Water entry on the rear / "C" pillar, left and right sides.
- 7 - Water entry on the left and right side glass roof seals.
- 8 - Water entry on the top of the rear window, left and right sides.
- 9 - Water entry at the transition ramp rear window inside bracket.
- 10 - Water entry on the rear body center piece, left and right sides.

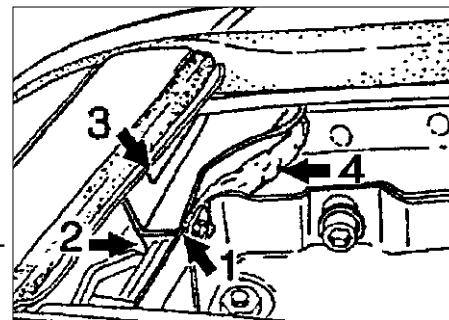
Figure 1

Area #2 Water entry above the left and right "A" pillar - windshield frame / roof module water channel on the windshield frame seal.

- Incorrect position of the water channel in the windshield frame seal.

- The complete water channel must enter into the guide rail and be slightly bent to the outside. It must not protrude on the side (arrow 1, figure 1). The sides must be bent without kinks slightly to the top.

The end piece (arrow 2, figure 1) must point straight to the bottom into the guide. The drip pan which is located below the side wind deflector (sheet metal strip, arrow 3, figure 1) must go into the water channel and lay on the side of the channel. The water channel can be adjusted by installing butyl sealing strips or similar material (arrow 4, figure 1). All areas of the channel must be even without any kinks. The rear end of the butyl sealing strip must connect with the guide rail on the inside of the side wall (arrow 1, figure 1)

A space of approximately 2 mm must be present between the butyl sealing strip and the sun screen rolling shaft. If the distance is too small, butyl material may wrap around the rolling shaft and affect its operation.

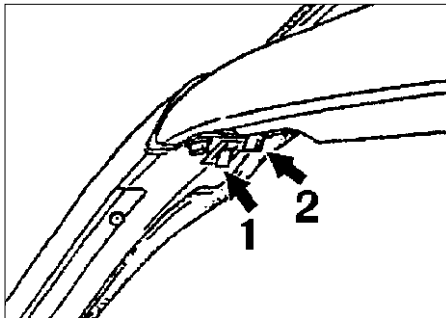
Figure 2

Area #3 **Water entry on the formed seal piece of the left and right top door seal / "A" pillar transition of the water drainage pipes of the windshield frame seal and the roof frame to the formed piece on the door seal.**

- The transition of the water drain pipes of the seal and the roof frame to the formed piece on the door seal (area of "A" pillar) does not exist.

- Remove the holding bracket for the door seal formed piece on the inside (if installed).
- Remove the 4 bolts from the door seal bracket on the roof frame.
Pull the seal off in the area of the "A" pillar.
- Remove the sealing material from the bottom of the seal and seal base.
- Install a clamp (part number 999 507 542 01, arrow 1, figure 2) onto the plastic hose of the windshield frame seal. This prevents the plastic drain hose from moving to the top when installing the door seal.
- Install a 2 mm wide strip of sealing butyl around the metal drain pipe (arrow 2, figure 2) of the roof frame.
- Lay butyl material on top of the formed piece on the door seal (arrows A and B, figure 3).

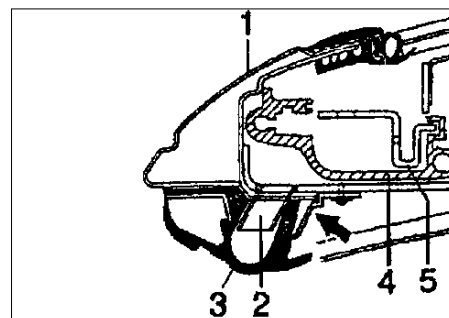
Figure 5

- 1 - Roof frame
- 2 - Water drainage pipe
- 3 - Door seal
- 4 - Guide rail
- 5 - Carrier bracket in the guide rail

- Reinstall the door seal. Ensure that the water drain pipe is properly installed in the opening of the door seal and the butyl seals are not moved.
- Secure the door seal onto the roof frame with the bracket.
- Reinstall the holding bracket (part number 993 562 571 00, arrow, figure 4) for the door seal on the inside.
- The holding bracket (part number 993 562 571 00) must be service installed since it was not done in production. This bracket should be installed as shown (arrow figure 5) to a 3 mm hole drilled into the roof frame.

- Fill the hole with body sealer and install the bracket with a sheet metal screw (4 mm dia. by 6 mm long). Install the door seal into the correct position and set the bracket into place. Bend the bracket to the outside until the teeth of the bracket contact and hold the door seal rubber.

Position the holding bracket to the center of the drain pipe of roof frame and flush with the bottom edge of the roof frame.

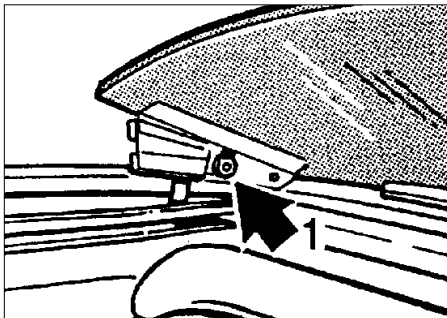
Figure 7

Area #4 Water entry on the air deflector

Insufficient pressure on the air deflector seal by the air deflector. The lip of the side seals (left and right) touches the bracket ends of the air deflector.

With the air deflector open, loosen the left and right holding nut (arrow 1, figure 7). Adjust the air deflector within the elongated slots so that in the closed position the deflector places a light preload on the seals.

The air deflector must be even with the glass roof and the side trim after adjustments. Tighten the left and right holding nuts to 5.5 Nm (4 ftlb).

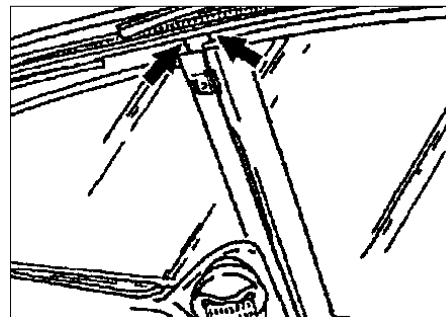
Figure 9

Area #5 Water entry on the top of the left and right "B" pillar.

A gap in the upper corner of the "B" pillar and roof frame.

- Close the gap on the "B" pillar (arrows, figure 9) to the roof frame in the area above the coat hook using body sealer.

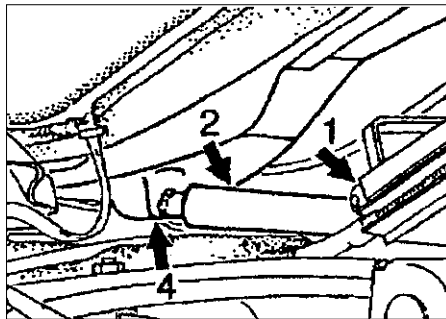
Figure 10

Area #6 Water entry in the rear "C" pillar area on the left and right sides.

- The guide rail leaks at the lower end (arrow 1, figure 10).
- The water drainage pipes (arrows 2 and 3, figure 10 and 11) maybe damaged or incorrectly installed.
- The water drainage connector (arrow 4, figure 10 - drainage from the rear window) may be leaking.

- Seal the area of the guide rail unit with body sealer (arrow 1, figure 10).
- Correct the installation or if needed, replace the drain pipes (arrows 2 and 3, figure 10 and 11).
- Seal the drainage connector with body sealer (arrow 4, figure 10).

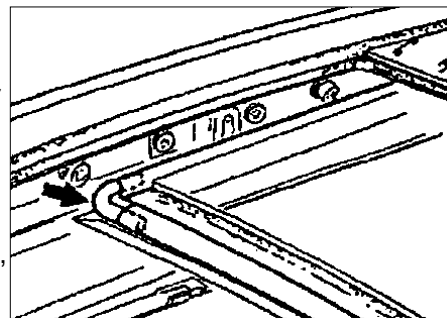
Figure 12

Area #7 Water entry on the left and right side glass roof seal.

- Possible openings on the corners of the glass roof seal. Water can run through the seal toward the rear and enter the passenger compartment.

- Close the open ends of the glass roof seal using rubber cord (part number 999 911 088 50) 7mm dia., 45 mm in length (arrow, figure 12).

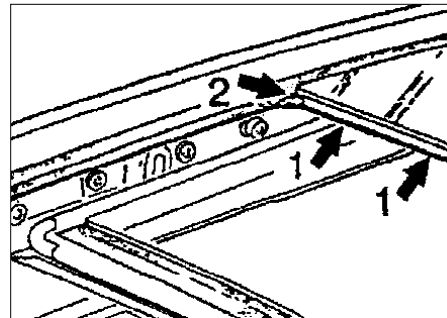
Figure 13

Area #8 **Water entry on top of the rear window on the left and right sides.**

- Improper sealing of the rear window frame at the front upper area (arrow 1, figure 13).
- Possible openings on the front corners and / or the transition between the rear window and side seals (arrow 2, figure 13).

- Close any gaps using body sealer.

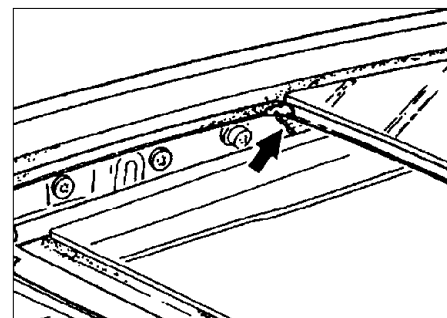
Figure 14

Area #9 **Water entry at the transition ramp rear window inside bracket above the roof frame left and right sides.**

Insufficient sealing of the transition ramp.

- Press sealing material between the roof frame and the rear window inside bracket (arrow figure 14).

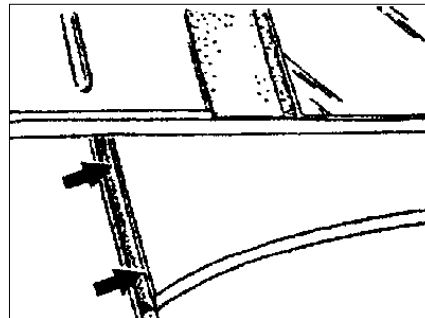
Figure 1

Area #10 **Water entry on the rear body center panel at the side seam connections to the left and right side members.**

- Inadequate sealing.

- Seal the gap between the rear body center panel (arrows, figure 14) and side members from the outside using silicone free body sealer. Depending on the body color, a light or dark sealer should be used which can be painted.

- Angle the tip of the sealer cartridge. Start at the bottom of the seam and apply the sealer. Remove any excessive sealer.
- After approximately 30 minutes drying time, paint over the sealer in the vehicle exterior color.
