Technical Bulletin

Repairing Cabriolet Top

Number
9508

Models Affected: *911 Carrera Model Year 1995*

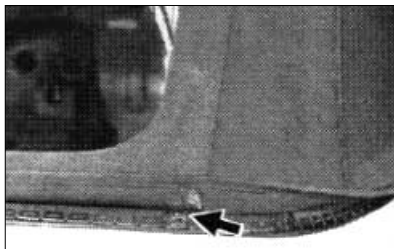
Figure 5

Concern 4.

Rear window has vertical buckle marks.

Cause:

The radius for storing the rear window is too small.

As a solution, from the end of June 1994, spring supports are installed on the left and right sides of the top tensioning frame. With this solution, proper storage of the rear window is assured.

Repair:

The two spring supports can be installed into earlier vehicles using pop-rivets (Arrows in figure 5 and 6).

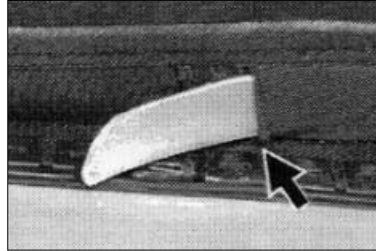
Figure 9

Concern 5:

Cabrio top material on the rear left and right sides lifts up.

Cause:

The top material has been cut too close.

- Carefully insert the aluminum filler piece into the opened seam of Cabrio top (Figure 9).

- The aluminum filler piece must fit fully into the seam slot and should not protrude from the seam slot.
- Flip down the Cabrio top material and form the aluminum filler piece to the body contour.

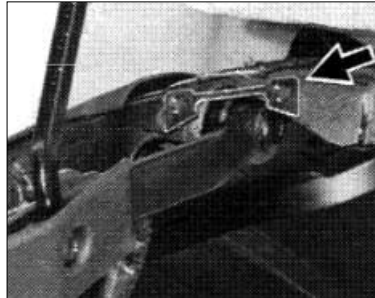
Figure 10

Concern 6.

Flutter noises from the Cabrio top material in the area of the folding bow and tensioning straps.

Cause:

The tensioning straps touch the top material.

- Open the Cabrio top fully (remove windstop if installed).
- In the area of the main bow hinge, move the Cabrio top material to the side and check if the folding bow tension strap is fully glued on the main bow. If not, reglue the strap to the main bow.
- Cut the tensioning strap off flush with the edge of the main bow.
- Cut the tensioning strap off at the folding bow.
- Position the new tensioning strap bracket on the main bow and mark the holes for drilling. The bracket should be located approximately 1-2 mm below the upper edge of the main bow (Figure 10).

- Drill holes with a 3.3mm drill bit approximately 12mm deep.
- Slightly countersink the holes and tap them for M4 threads. Remove the shavings carefully.
- Install the clamping plate onto the new tensioning strap and install onto the folding bow.
