Noises from the Targa Roof Area

Binder-Service Technical Bulletins  
This bulletin replaces bulletin Group 6, #9606, dated 9-26-96.

Vehicle Type: **911 Targa, Model Year 1996**

Model Year: **As of 1996 (T)**

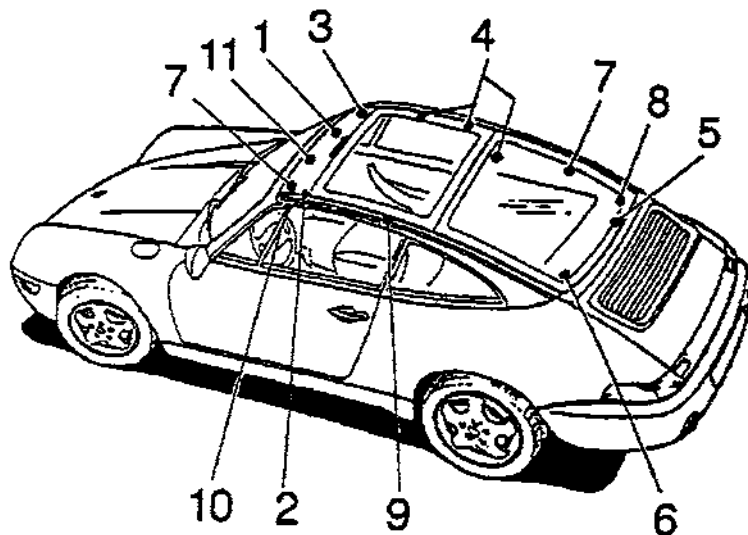
- 1 - Creaking in the area of the wind deflector.
- 2 - Creaking at the left and right sides of the sliding glass roof panel.
- 3 - Strong rattle noises in the area of the windshield frame and roof module.
- 4 - Rattle or crackling noises in the area of the B-pillar, roof frame and glass sliding roof panel (left and right sides).
- 5 - Creaking noises in the area around the rear window.

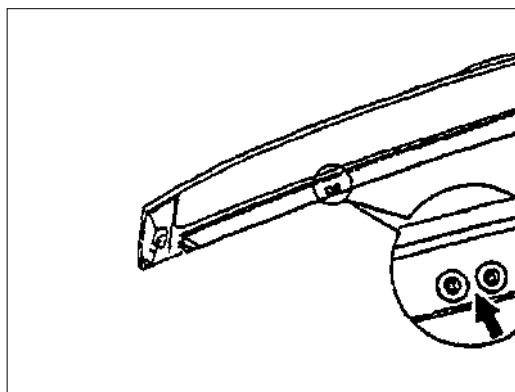
Figure 1

- Loose bolts or threaded inserts for the wind deflector.
- Front hinge link binding.
- Play in the wind deflector drive cables.

**1.1 Loose bolts or threaded inserts (Figure 1, arrow 1).**

Replace loose bolts and torque to 5.5 + 0.5 Nm (4 ft/lb).

**Note:** As of January 20, '97 the bolts were replaced with torx bolts, part number, 993 562 577 01. Only this bolt is valid for repairs. If the threaded inserts come loose (Figure 1, arrow 1), the wind deflector, part number, 993 562 904 00 and the bolts should be replaced.

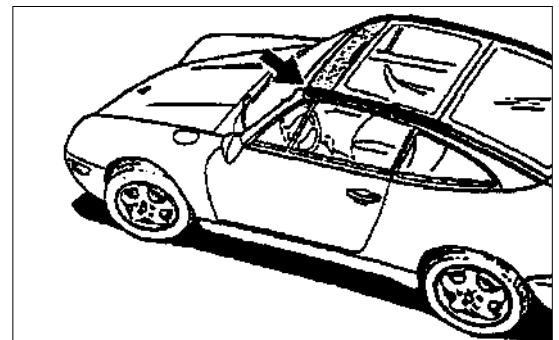
Figure 6

**2.1 Creaking at the left or right sides of the glass sliding roof panel**

The side seals are sticking together.

**2.1** With the wind deflector and roof open, pull off the front edge of the side seal and locate the opening at the end of the seal (Figure 6, arrow). Use a suitable wire coated with vaseline to lubricate the inside of the seal along its entire length.

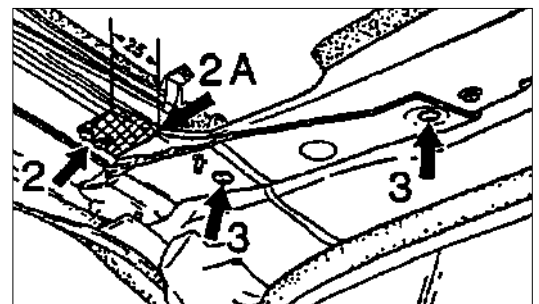
Figure 7

**3.1 Strong rattle noises in the area of the roof module and windshield frame (center, left or right).**

Tension on the wind deflectors bearing block, located on the roof frame and the connection for the cross bracket.

**3.1** Shorten the corner plate bracket in the area of the bearing block holes. (Figure 7).

- Remove the allen head screws (Figure 7, arrow 2).

- Remove the area indicated by crosshatch (Figure 7 arrow 2).
- Protect by inserting a screwdriver between the corner plate and the guide and bend the crosshatched area away from the guide 3 to 4mm.
- To prevent damaging the guide, insert a 40mm x 50mm, 2mm thick sheet metal plate, between the guide and carrier plate.
- Cut off the hatch-marked part at a length of 25mm (Figure 8, arrow 2A).

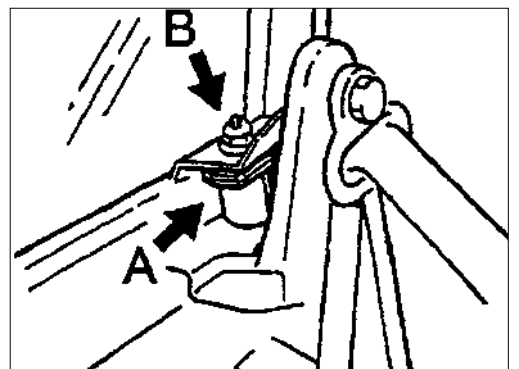
Figure 12

**4.1 Distance spacer on the B pillar (Figure 12, arrow A) loose (left or right)**

- Remove the cowl trim panel rear wall cover panel and the inside roof panels.
- Check distance bushing (Figure 12, pos. A) for tightness and correct seating.
- Retorque M6 nut (Figure 12, pos. B) to 9.7 Nm (7 ft/lb).

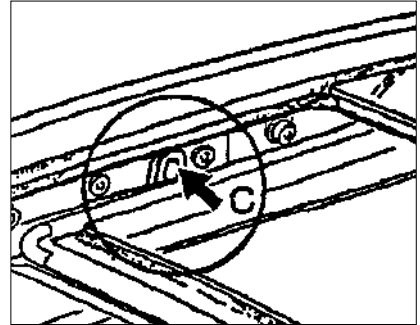
Figure 13

**4.2 Missing rubber stop for the guide pin of the glass roof latch (left or right).**

- Open the glass roof completely and check if the rubber stop, part number, 993 562 810 00 for the guide pin of the glass roof is installed (Figure 13, arrow). The rubber stop is approximately 50mm in front of the rear window on the guide tracks and is only accessible when the roof is fully open.
- If missing, install a new rubber stop using soapy water or vaseline. Slide the thin side of the stop from the bottom into the hole using a screwdriver (Figure 14, arrow C). Cut off the excess rubber on top.

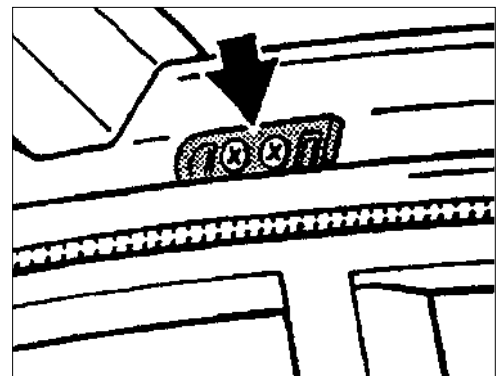
Figure 15

**4.3 Lack of lubrication for the guide bushing on the rear axle plates (left or right).**

- Remove left and right roof frame covers.
- With the glass roof closed remove the rear axle plate (Figure 15, arrow)
- Lubricate the guide bushing of the axle plate with thick grease, part number, 999 917 751 00.
- Remount axle plate and adjust the glass roof height according to the roof seal. Torque to 5.5 Nm (4 ft/lb).

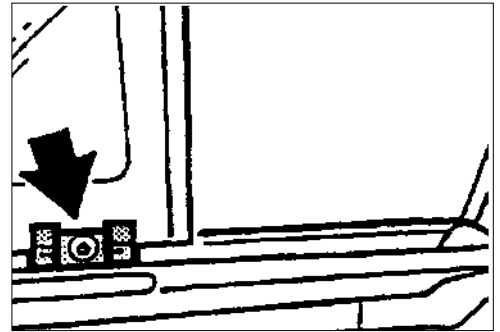
Figure 16

Repair: (cont'd) **4.4 Guide pin for the front axle plate of the glass roof is worn (left or right).**

Replacement of the left and right axle plates.

- Remove left and right inner roof covering.
- Open glass roof approx. 250mm. Remove front axle plate (Figure 16, arrow).
- Replace the old axle plate, which has a black surface, with the new version which is nickel plated (lighter colored).

- Bolt on the new axle plate on the left and right sides and adjust the glass roof panel height. To avoid air noises the upper edge of the glass roof panel should be 0.5 to 1.0mm lower than the rear edge of the wind deflector in the closed position. Torque screws to 8.3 + 0.5 Nm (6 ft/lb).
- Figure 17, additional view of glass roof panel with axle plate.

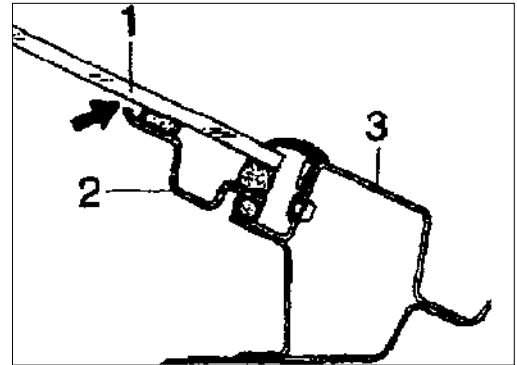
Figure 18

**5.1 Creaking noises from around the rear window.**

- The rear window mounting frame (Figure 2, pos. 2) touches the rear glass.

- Remove the rear wall panel. Check for clearance using a 2.0mm feeler gauge (Figure 18, arrow).

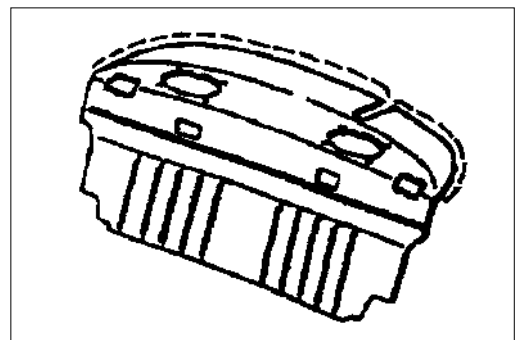
Figure 20

**6.1 Creaking noises in the are of the rear cover and window.**

The edge of the rear wall trim panel touches the rear glass, C pillar covers or side covers.

- Install a length of felt material, part number, 993 555 545 00 onto the edge of the rear wall trim panel (Figure 20). As of October 12, '95 vehicles with leather covered rear wall trim panels have the felt strip installed in production.

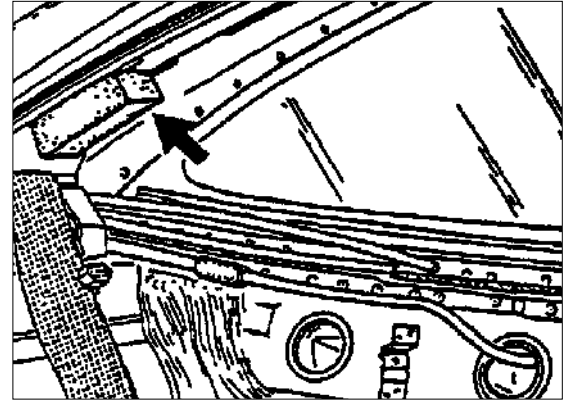
Figure 21

**7.1 The roof trim panel touches the metal roof frame (left or right).**

- Remove the rear wall trim panel, roof rail trim panels and the windshield frame cover.
- Glue foam pieces (approx.. 100mm long) to the inside of the roof rail trim panels at the location shown in figure 21.

- a. Behind the rear securing element of the roof rail trim panels. (Figure 21, arrow).
- b. Between the rear securing element and the B pillar. Part number, 993 556 245 00, foam piece (left and right).

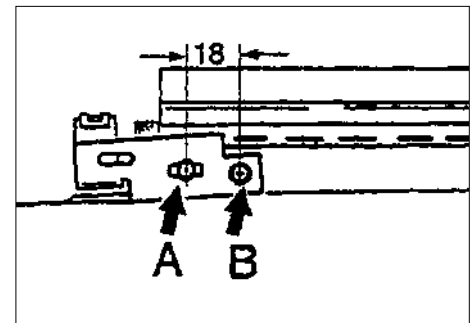
Figure 22

**7.2 The center securing supports for the roof trim panels on the left or right sides are loose.**

- On the removed roof trim panel, secure the loose rivets (Figure 22, arrow A) on the center securing point for the B pillar.
- Install an additional securing screw (Part number, 993 562 737 00) on the bracket (Figure 22, arrow B).

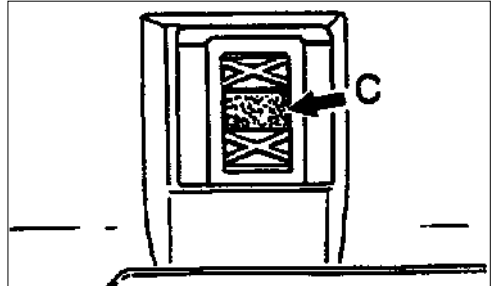
Figure 23

**7.3 Play on the front or rear securing elements (left or right).**

- With roof trim panels removed, glue foam pieces, approx.. 12 X 10mm and 5mm thick in the indentations of the securing part (Figure 23, arrow C)

**Important:** The glued-in foam pieces (Figure 23, arrow C) must stand approx.. 1 to 2mm over.

- If securing element is loose install two additional screws. Drill two holes 2mm in diameter, by 7mm in depth, through the securing element into the roof trim panel (Figure 24, arrow D). Secure the elements with two sheet metal screws (Torx T20).

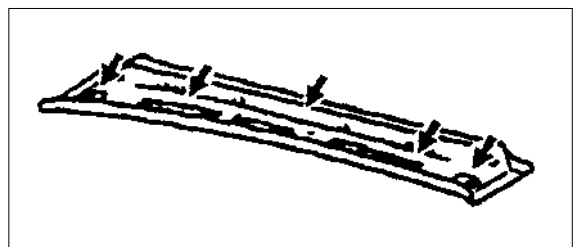
Figure 25

**7.4 The windshield frame cover touches the screw heads.**

- Check the inside of the windshield frame cover for touching or rubbing signs (Figure 25, arrows).
- Carefully remove high spots from the inside of the cover, if necessary install a thin foam sheet.
- Remove the four sheet metal screws and reinstall without washers.

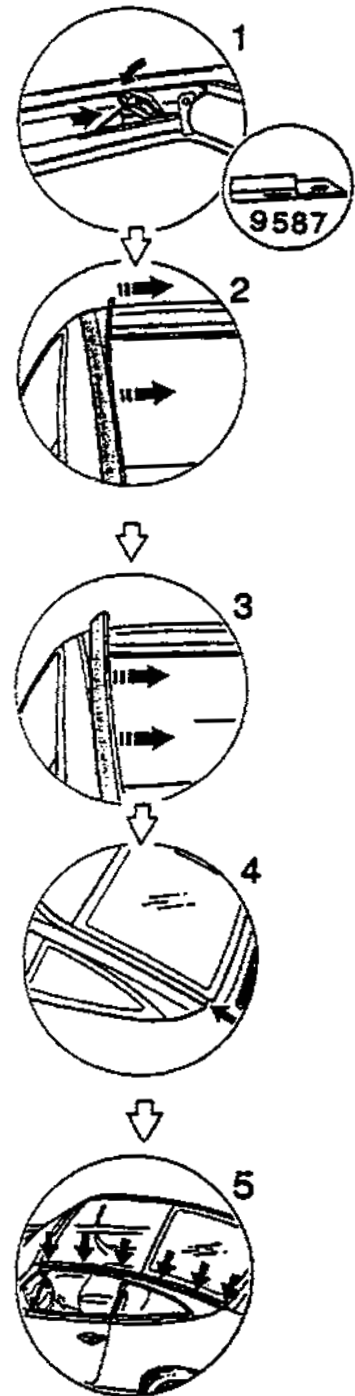
Figure 27

**Creaking noises in the area of the outside roof rail trim strips (left or right sides).**

- The roof rail cover strips are installed under tension.

- Remove the wind deflector and fully open sliding roof.
- Use the appropriate 9587 tool (left or right) for the side of the vehicle being repaired (Figure 27, pos. 1). Insert the tool into the guide rail channel behind the cable driver. Use a screwdriver to push the tool 9587 into the cable driver which will allow the cable driver to move forward. This will cause the fold-up lever to move down toward the rear. Leave the tool in place while repairs are being made.

- Pull out the rubber roof seal, starting at front (Figure 27, pos.2).
- Remove the roof trim strip, starting at the front (Figure 27, pos.3). If necessary use a piece of hardwood covered with leather and light hammer taps to dislodge the strip.
- Remove the roof trim strip in the rear. Use a piece of hardwood covered with leather and light hammer taps, starting at the rear (Figure 27, pos. 4).
- After the trim strip is completely removed, clean the body flange thoroughly and remove any foreign material or existing teflon strip (Figure 27, pos. 5).

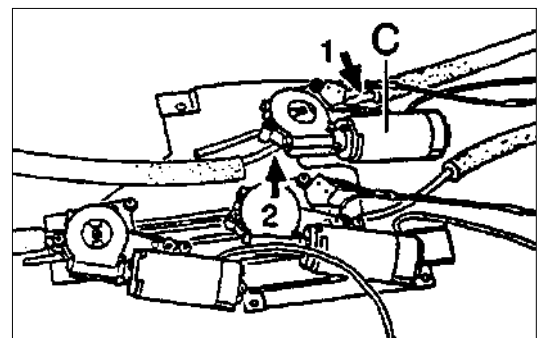
Figure 31

**11.3 One sided loss of tension of the sun screen.**

- Remove rear wall trim panel.
- Fully extend the sun screen.
- Remove the drive motor for the sun screen (Figure 31, pos. C).
- Pull the respective drive cable with needle nose pliers until the loose side is tight.

- Reinstall drive motor. Torque bolts to 3.0 Nm (2 ft/lb)
