Subject: New Alternator has Integrated Regulator

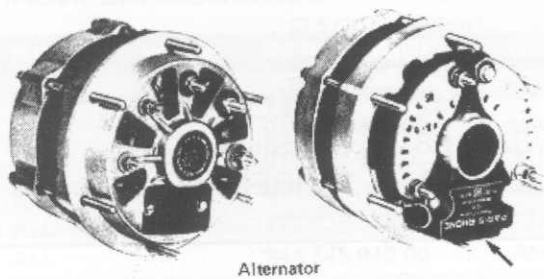
Alternator

New-type alternator, part number 911 603 120 04 with integrated regulator, is now installed instead of former version, part number 911 603 120 02, which used a separate regulator. Regulator of the new version, part number 911 603 913 01 is located on the back of the alternator and can be replaced separately. Threads on the alternator shaft for installation of pulley have also been changed from M16 x 1 to M17 x 1.5.

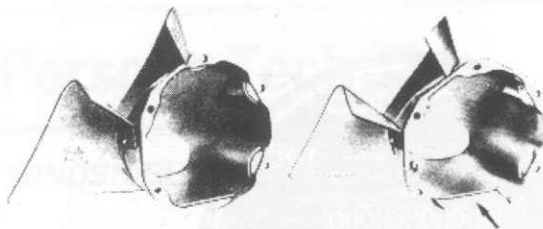
Air guide

The hub extension (air guide) has been modified to provide an opening for the regulator. Battery charge indicator lamp is changed from 2 watt to 4 watt, and the DF wire was removed from engine wire harness.

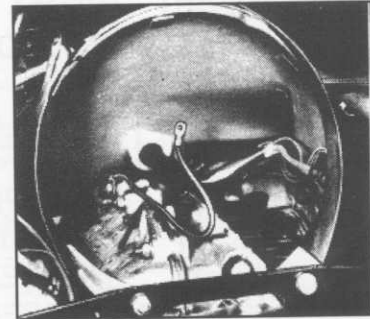
Figure A

Caution: A ground wire, part number 911 612 233 00 was not installed between the crankcase and alternator on some early 1982 models. A poor ground connection can cause radio interference and a discharged battery.

If the above problems develop, or if the alternator has to be removed for repairs, install missing ground wire as shown in figure A.
