Clutch Pedal Noise

Vehicle Type: **911 Carrera (996), 911 Carrera 4 (996)**

Model Year: **As of 1999 (X)**

Concern: **Noises during actuation of the clutch pedal.**

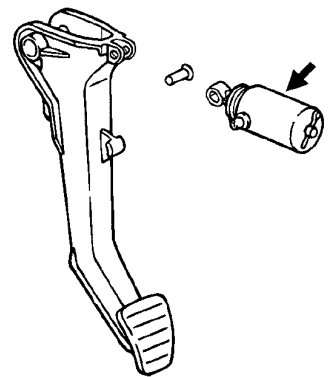
Figure 1

Cause: The clutch pedal reinforcing rib rubs on the bracket (see arrow in figure 1). This noise is only slightly audible.

Repair: Remove the clutch pedal and rework the reinforcing rib with a file.

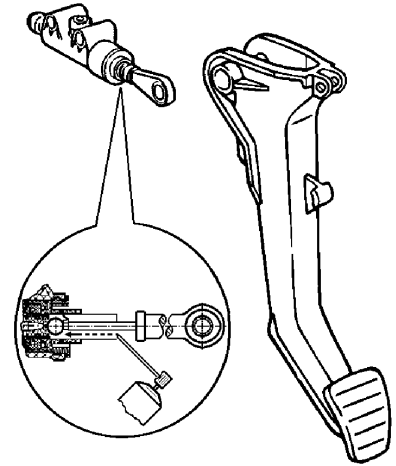
Figure 2

Cause: The clutch pedal power assist spring rubs against the spring casing.

Repair: Replace the clutch spring with a new contoured version clutch spring (see arrow in figure 2).
