Porsche 928 Tech: Check Your A/T Flex Plate

Richard Andrade
Elektronik Repair, Inc.
www.elektronikrepair.com
elektronikrepair@earthlink.net

Dan Warner
Exotic Motorwerks
www.exoticmotorwerks.com
exoticmotorwerks@hotmail.com

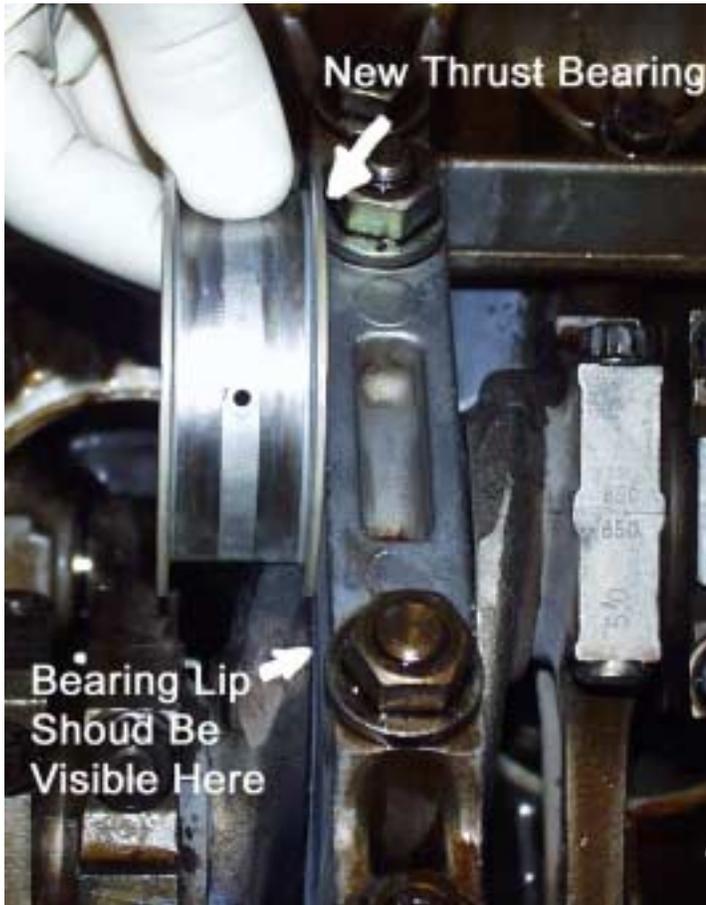
It wasn't until I was visiting Exotic Motorwerks, my Phoenix, AZ 928 specialist, that I saw the extent of the possible damage. Dan Warner, Exotic's co-owner, showed me an engine that was destroyed because of this problem. Figure 2 shows a new thrust bearing and the damaged block. Figure 3 shows the uneven crankshaft position as a result of the failure, and figure 4 shows the damage where the crankshaft contacted the engine block.

Figure 2. New Thrust Bearing and Damaged Block.

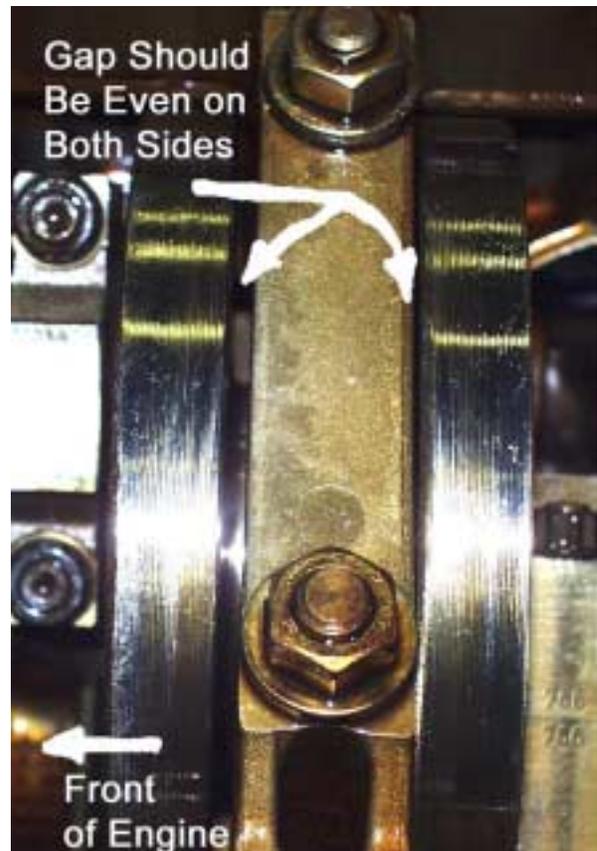
Figure 3. Failed Thrust Bearing and resulting Uneven Crankshaft Position

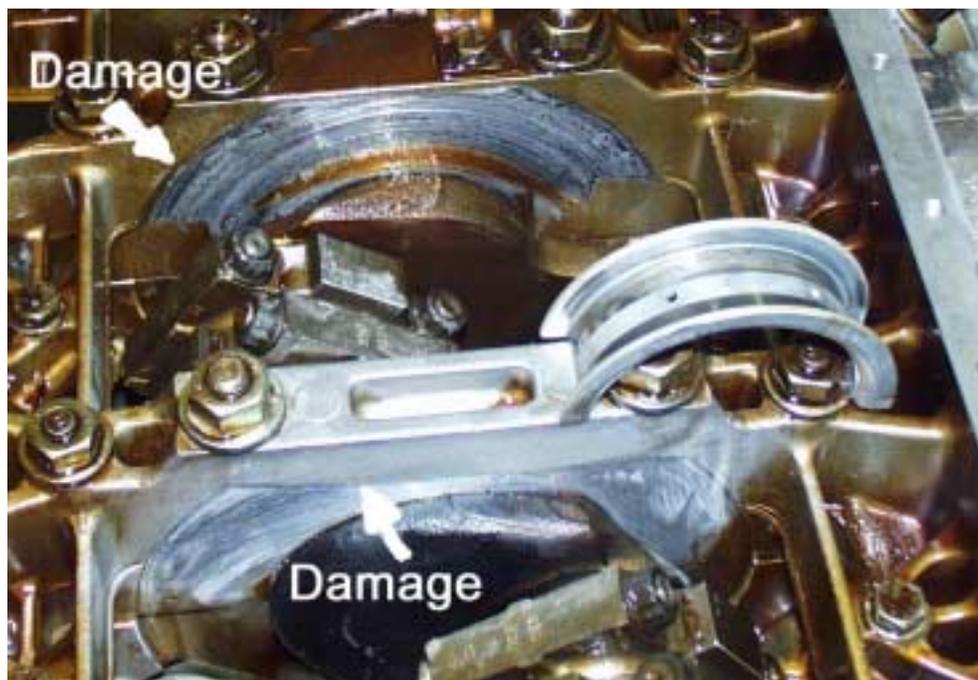
Figure 4. Block Damage.

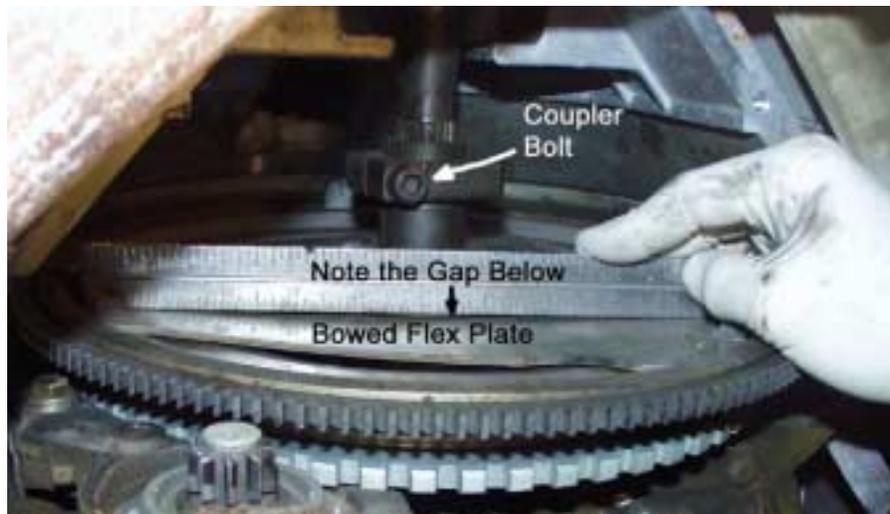
If there is pressure from the driveshaft toward the flex plate, the flex plate bows in the direction of the flywheel. This distortion can be easily seen by placing a ruler across the flex plate. Figure 6 shows this distortion.

Figure 6. Bowed Flex Plate.

To release the tension on the flex plate, the coupler bolt is loosened. The flex plate quickly snaps into an undistorted form. Dan made a precautionary one revolution hand crank of the engine to ensure all tension is released from the drivetrain. Figure 8 shows the flex plate as it should be, flat as the ruler.

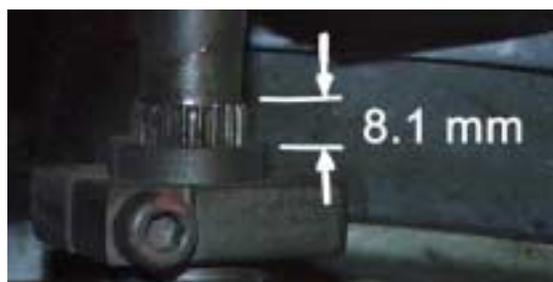
Figure 7 Initial Spline Measurement.

As illustrated in Figure 7, my 1993 928 GTS' initial reading was 8.1 mm of driveshaft spline showing.

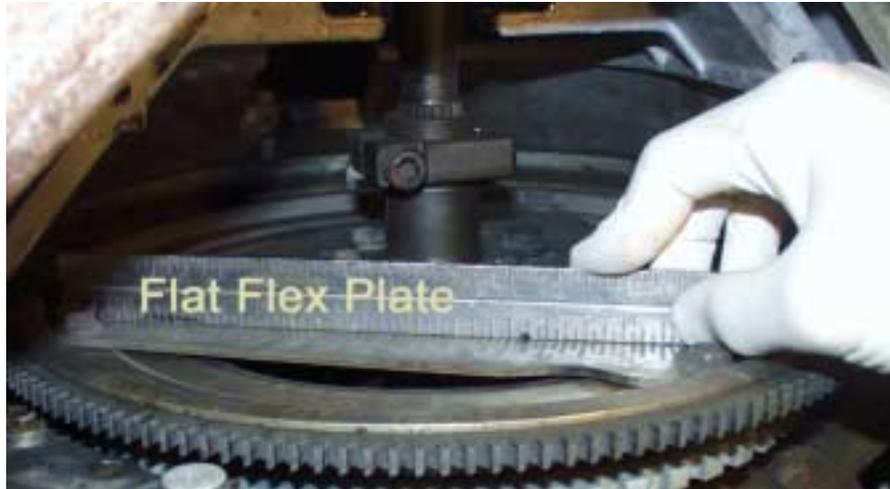
Figure 8. Flex Plate with no Tension.

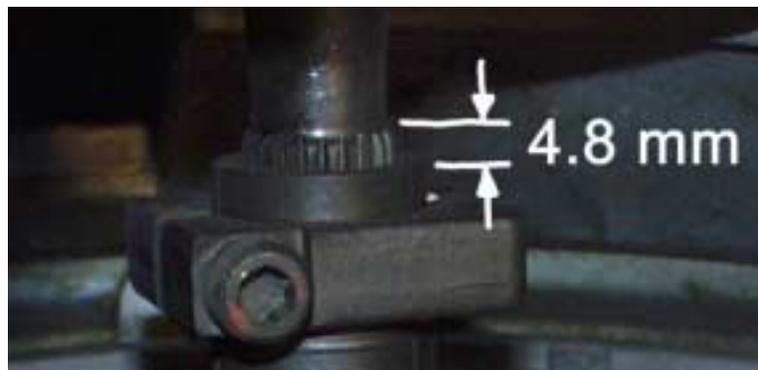
To illustrate the amount of tension on the system, Dan measured the driveshaft splines after the tension was release. As Figure 9 illustrated, there was 4.8 mm of remaining exposed splines. So the flex plate was distorted towards the engine by 3.3 mm (.13 inch).

Figure 9. Final Spline Measurement.

The factory torque specs for the coupler bolt is 60 lb-ft. Rennlist posters recommended cranking the bolt torque up to 66 lb-ft, so that torque was used.
