97 50 41 Repairing wire harness no. 173 (DME)**Note**

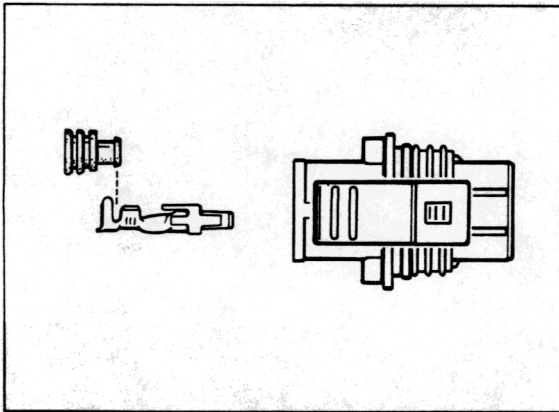
2309-97

As of model year 1996, knock sensors, speed senders and temperature sensors with optimized plug connections will be installed. In this case, the connector housing of older wire harnesses must be modified.

1. Cut wires right next to the old connector housing.
2. Push new sheaths onto each individual wire and insulate wires on a length of approx. 5 mm.
3. Use a crimping tool to crimp the connector contact and the sheath.

4. As for the terminal assignment in the connector housing, the wiring diagram and the following table must be observed.
