97 50 41 Repairing wire harness no. 173 (DME)**Note**

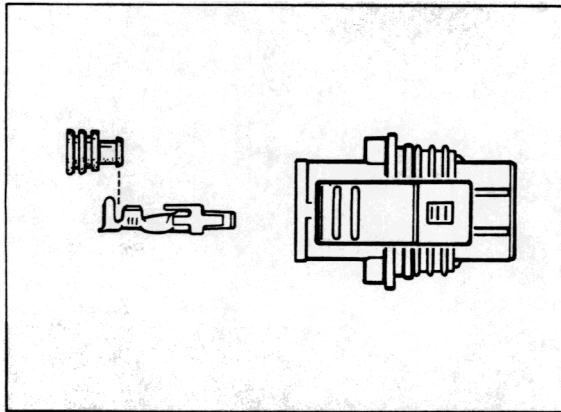
2309-97

As of model year 1996, knock sensors, speed senders and temperature sensors with optimized plug connections will be installed. In this case, the connector housing of older wire harnesses must be modified.

1. Cut wires right next to the old connector housing.
2. Push new sheaths onto each individual wire and insulate wires on a length of approx. 5 mm.
3. Use a crimping tool to crimp the connector contact and the sheath.

4. As for the terminal assignment in the connector housing, the wiring diagram and the following table must be observed.

5. Terminal 2 on the temperature sensor is not used and has to be fitted with a dummy plug.
