Noises from the Targa Roof Area

Binder-Service Technical Bulletins  
This bulletin replaces bulletin Group 6, #9606, dated 9-26-96.

Vehicle Type: **911 Targa, Model Year 1996**

Model Year: **As of 1996 (T)**

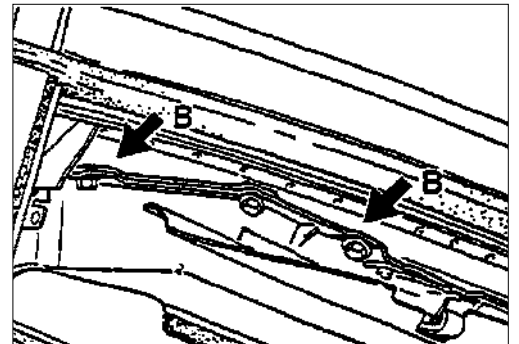
Figure 11

- The distance spacer on the B pillar may be loose (left or right).
- The rubber stop for the guide pin of the glass roof latch may be missing (left or right).
- Lack of lubrication on the guide bushing on rear axle plates.
- Guide pin for the front axle plate of the glass roof is worn (left or right).
