Porsche 928 Tech: Check Your A/T Flex Plate

Richard Andrade
Elektronik Repair, Inc.
www.elektronikrepair.com
elektronikrepair@earthlink.net

Dan Warner
Exotic Motorwerks
www.exoticmotorwerks.com
exoticmotorwerks@hotmail.com

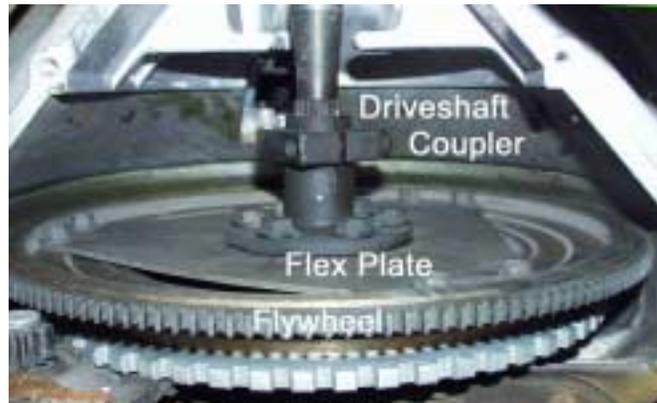
Figure 5. Flywheel, Flex Plate and Driveshaft.

At the rear of the engine block is the bell housing. Inside the bell housing is the flywheel. The driveshaft connects to the flywheel via a coupler that is attached to the flex plate. Figure 5 illustrates my GTS' layout.

If there is pressure from the driveshaft toward the flex plate, the flex plate bows in the direction of the flywheel. This distortion can be easily seen by placing a ruler across the flex plate. Figure 6 shows this distortion.

To release the tension on the flex plate, the coupler bolt is loosened. The flex plate quickly snaps into an undistorted form. Dan made a precautionary one revolution hand crank of the engine to ensure all tension is released from the drivetrain. Figure 8 shows the flex plate as it should be, flat as the ruler.

The factory torque specs for the coupler bolt is 60 lb-ft. Rennlist posters recommended cranking the bolt torque up to 66 lb-ft, so that torque was used.

Dan told me that the majority of S4 and newer 928s with automatic transmissions have had tension on the flex plate. Therefore, Dan recommends checking the flex plate tension at each major service. After all, if an additional one hour of labor saves the engine block, it is money very well spent!
