PORSCHE 928

32V'r V1 INSTRUCTIONS

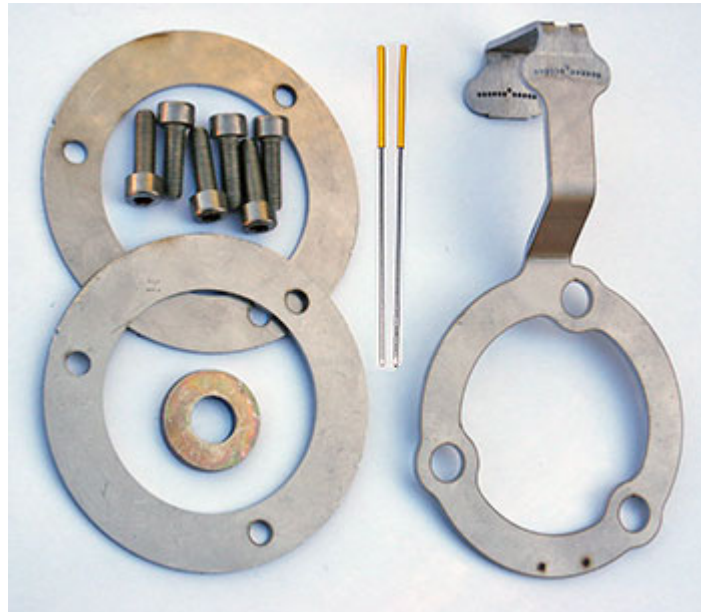
32V'r

Each hole is two crank degrees. The center, raised hole is zero.

When looking at installed tool, counterclockwise/left of zero hole is advance, clockwise/right is retard.

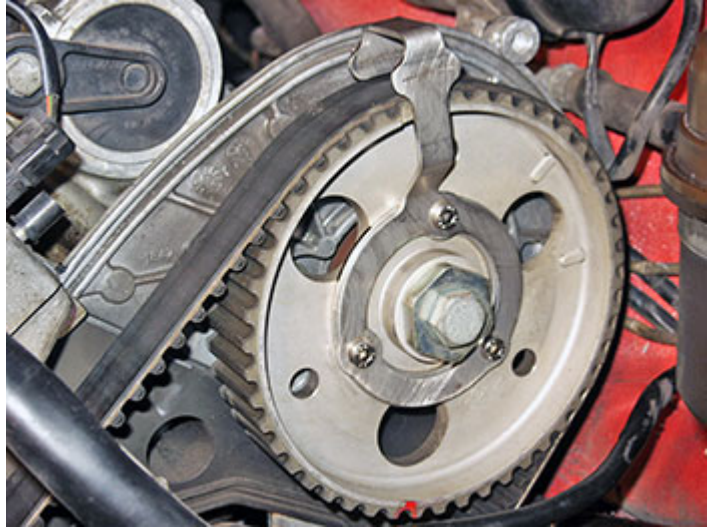
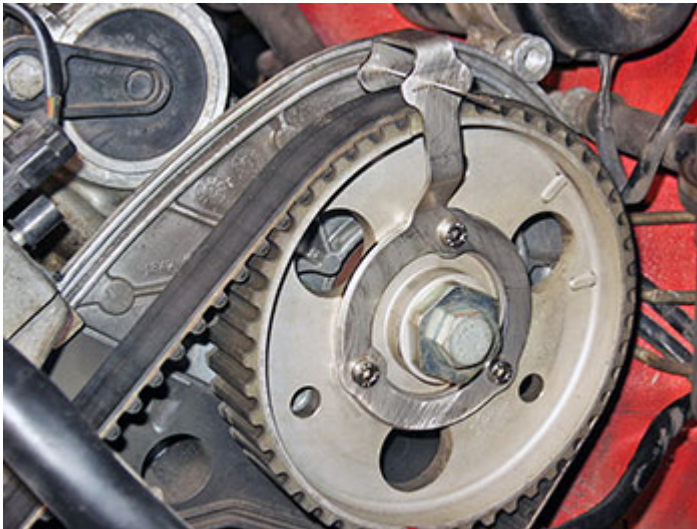
Slip 32V'r over clamp ring bolts.

Insert needle into hole that most closely fits into the housing indentation **V**.

Each hole is two crank degrees. Left of zero is advance, right retard.

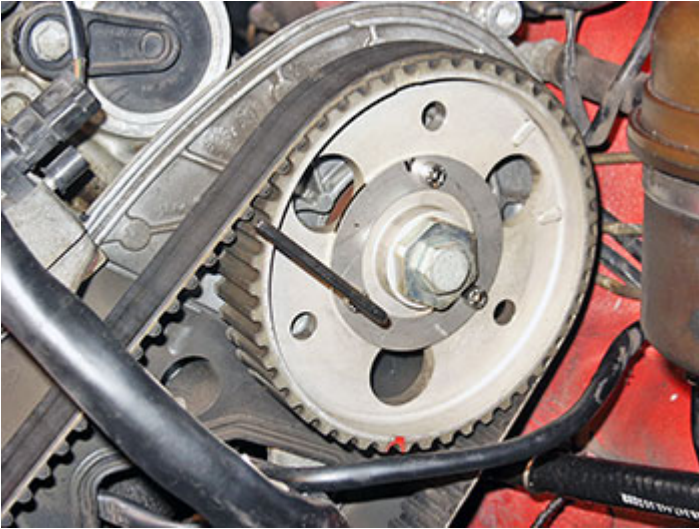
It is possible that the needle will not rest in the absolute center of the **V**.

Use two needles to split the difference, or use one needle, and swap in between two adjacent holes, for one degree.

Tighten clamp ring bolts.

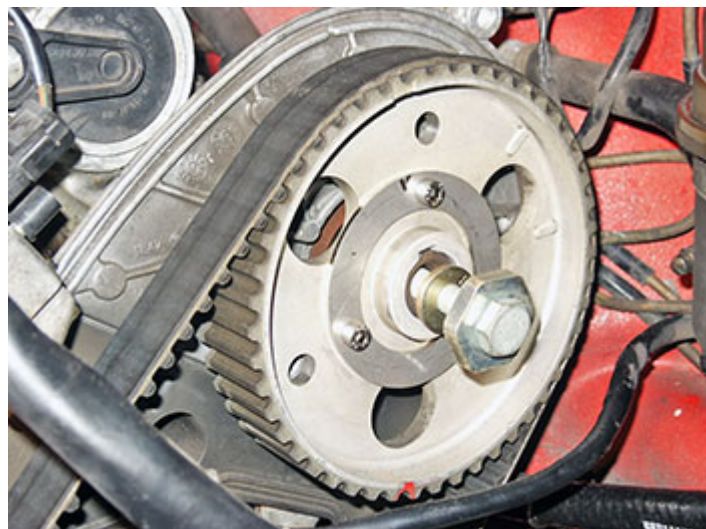
Counter hold cam bolt washer and loosen cam bolt.

Reinstall cam bolt with spacer.

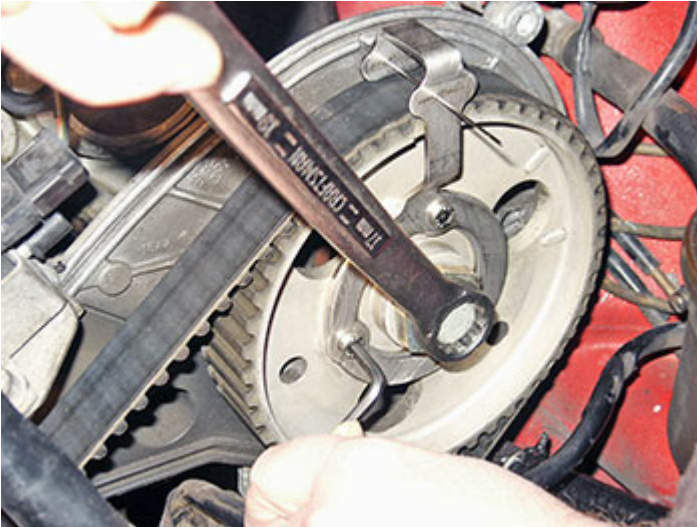
Counter hold cam bolt washer, tighten cam bolt to specification using torque wrench.

For advancing, or clockwise adjustment, slide indicator into the hole that corresponds to the amount of advance desired, with crankshaft at #1 TDC.

Loosen the clamp ring bolts and using a wrench on the cam bolt, rotate the cam bolt clockwise until the needle rests in the **V**.

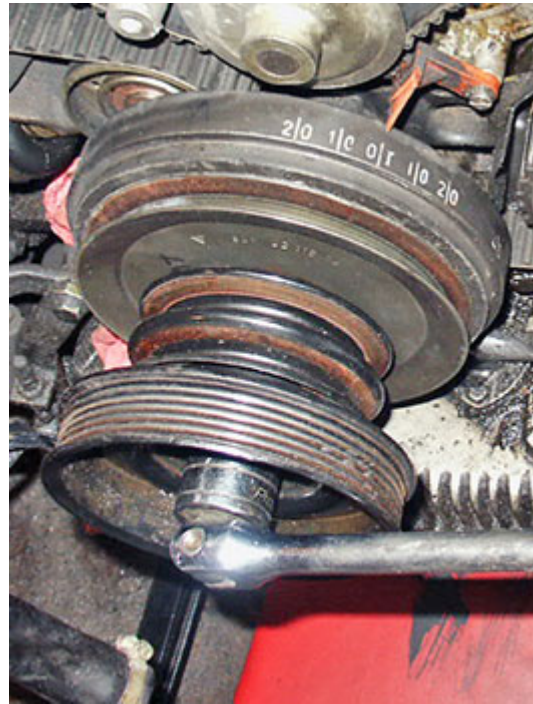
Loosen the clamp ring bolts, and while holding the cam bolt with a wrench, rotate the engine clockwise to #1 TDC.

While still holding cam bolt with wrench, tighten clamp ring bolts. Remove indicator.
